INSTITUT NATIONAL DE L'ENVIRONNEMENT INDUSTRIEL ET DES RISQUES

Explosion of a grain silo BLAYE (France)

Summary Report

july 1998

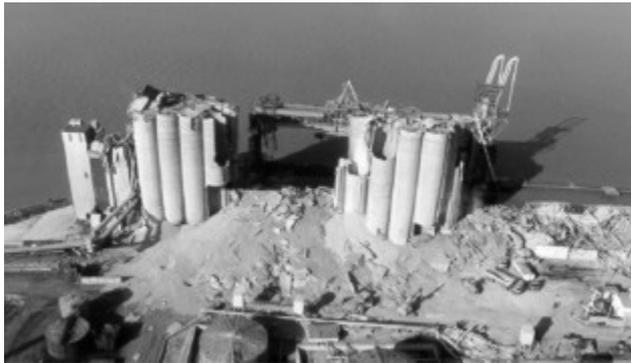
Generally speaking, the vertical silo collapsed in the centre and at the northern end. Of the 44 cells, only 16 appeared to be still largely in place after the incident, 9 of them in the southern part of the silo and 7 in the northern part (these figures refer to the number of cells that retained their cylindrical geometry over at least two-thirds of their original height). Accordingly one feature of this accident is that two groups of cells collapsed : a first set of cells to the north and linked to the handling tower ; a second set of cells from the central part of the silo.

The northern handling tower and the cells immediately adjacent were practically completely destroyed. All that remains, from half of its original height, is part of the curved half-shell of the structure of this tower, the sides of which – forming the walls of the adjacent interspace chambers (I5 and I6) – were pressed back on the barrel of cell C4. This situation suggests an explosion inside the handling tower, apparently taking place after possible explosions inside the neighbouring storage units.

The over-cell gallery was completely destroyed.

The southern tower seems to have fallen on top of the cells. Parts of the cleaner-separators (rubber balls from the screens) found with burned surfaces show that a flame or expanding burned gases passed through this tower.

Figure 5 : View of the vertical silo after the explosion

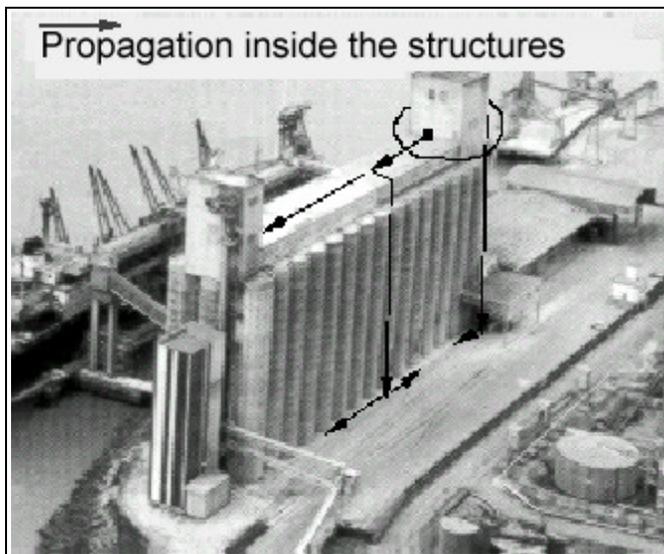
From the statements by witnesses it is possible to determine the space where the explosion initially began as the upper part of the northern handling tower. It propagated through the over-cell gallery as far as its southern end, probably owing to the fact that settled dust had been stirred up.

The explosion flames, probably in the form of a jet, were able to enter some storage units that were open. These were probably 2 in number, possibly 3.

The entry of the jet of flames into these storage units, which were extremely dusty owing to the loading operations, generated a violent explosion. The geometry of these storage units and, in particular, their elongated shape, would certainly have contributed to the development of the pressure effects. This applies particularly to the interspace chamber in which maize could be stored. It is recalled that since the height/hydraulic diameter ratio was close to 10, it is possible that this fact, together with the reactivity of the maize, largely explains the damage that occurred in the central part of the silo.

The explosion entered the space underneath the cells either from the bottom of the handling tower or, and this is more likely in our view, through the interspace chambers situated at the boundary between the two groups of storage units. According to this second assumption, propagation of the explosion through the interspace chambers would be such as to allow the flame to accelerate significantly, owing to the geometrical configuration, resulting in substantial pressure effects. In these circumstances the pressure waves emerging from the bottom of the interspace chambers would easily be of sufficient intensity to destroy the adjoining storage units and, to a large extent, the concrete shell separating the under-cell space from the outside. These openings in the under-cell space shortly before the arrival of the flame acted as vent areas, thus limiting the overpressure reached inside the under-cell space.

The destruction of the concrete shells of the under-cell space could therefore be the result of the pressure waves generated by the downward propagation of the explosion or the actual collapse of the structures. This sequence is coherent with the fact that the destruction of the concrete shells of the under-cell space took place rather late in the explosion process, as reported by witnesses.

Figure 6 : Assumed progress of the explosion
