STUDY REPORT  
DRS-15-149641-02735A

**LESSONS LEARNED FROM ACCIDENTS RELATED  
TO THE EXPLORATION AND PRODUCTION OF  
HYDROCARBONS**

## **Ground and Underground Risks Division**

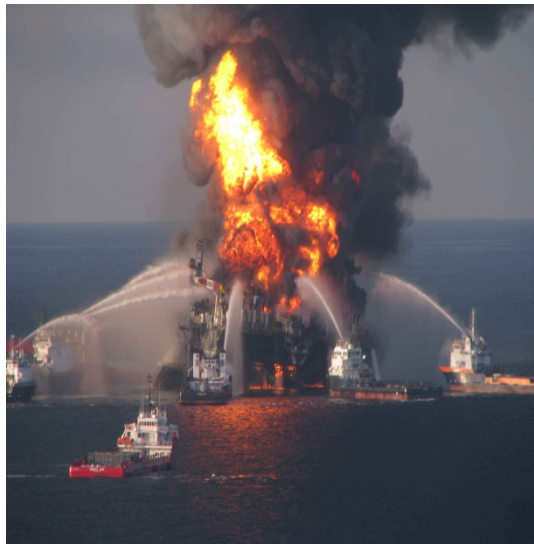
*Means mobilized to extinguish the fire*

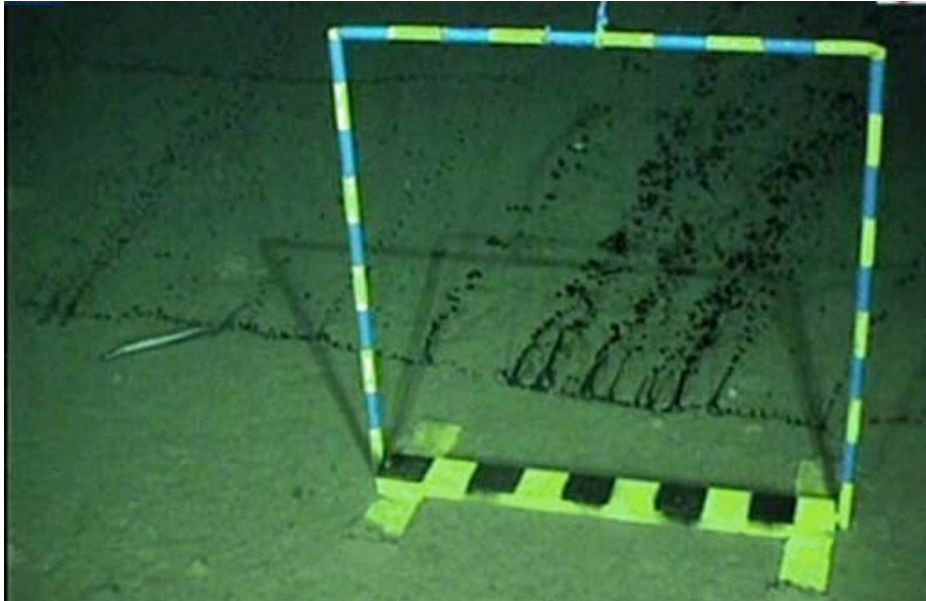
*Crude oil leak through a fracture created on the sea bed [4]*

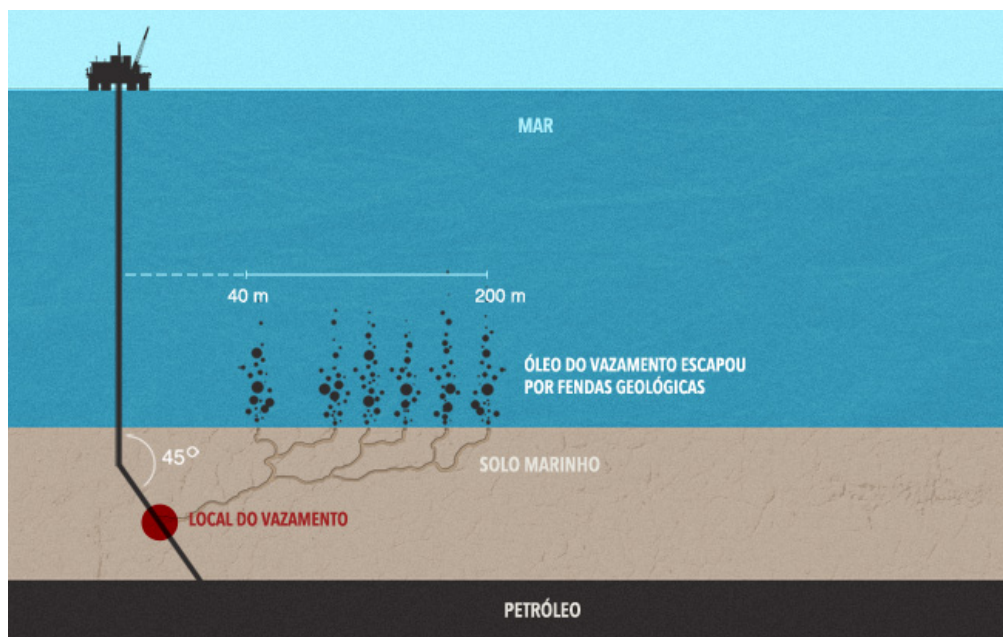
*Explanatory diagram: cracking of the sea bed and spread of crude oil [2]*

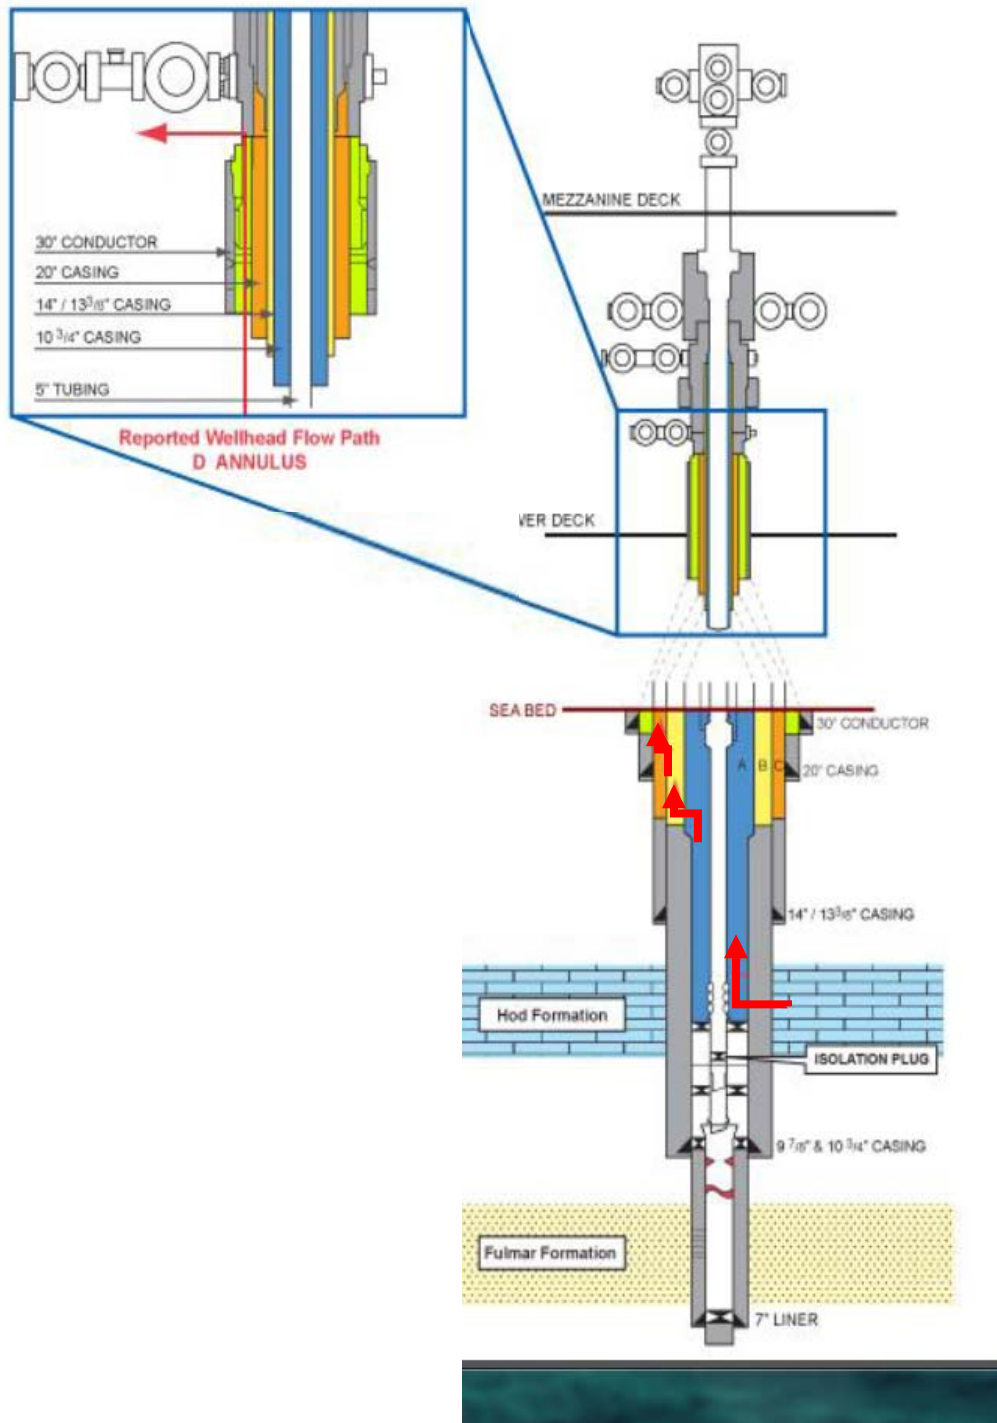
***Diagram of the propagation of the leak to the surface [5]***
