Ineris - 204910 - 2727405 - v1.0

25/01/2022

Mine tailings dam failures: review and assessment of the phenomenon

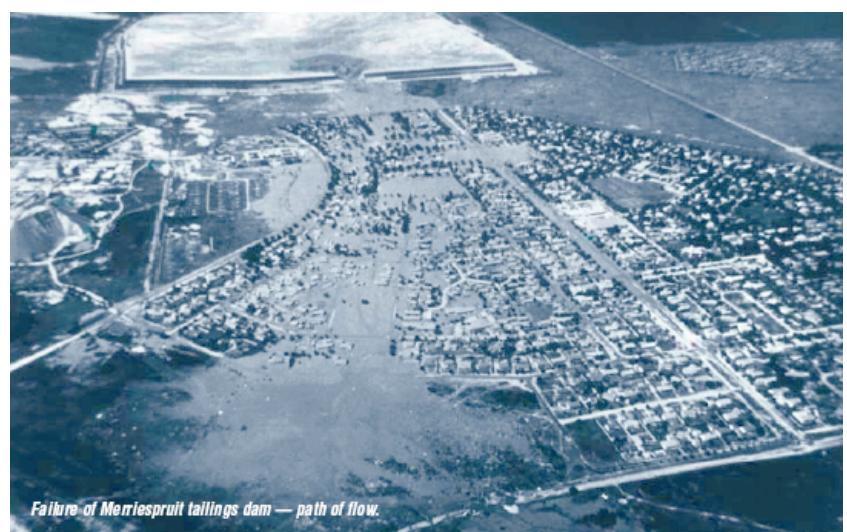
Figure 1: Merriespruit disaster, Harmony, South Africa, 1994, (ICME,[53])

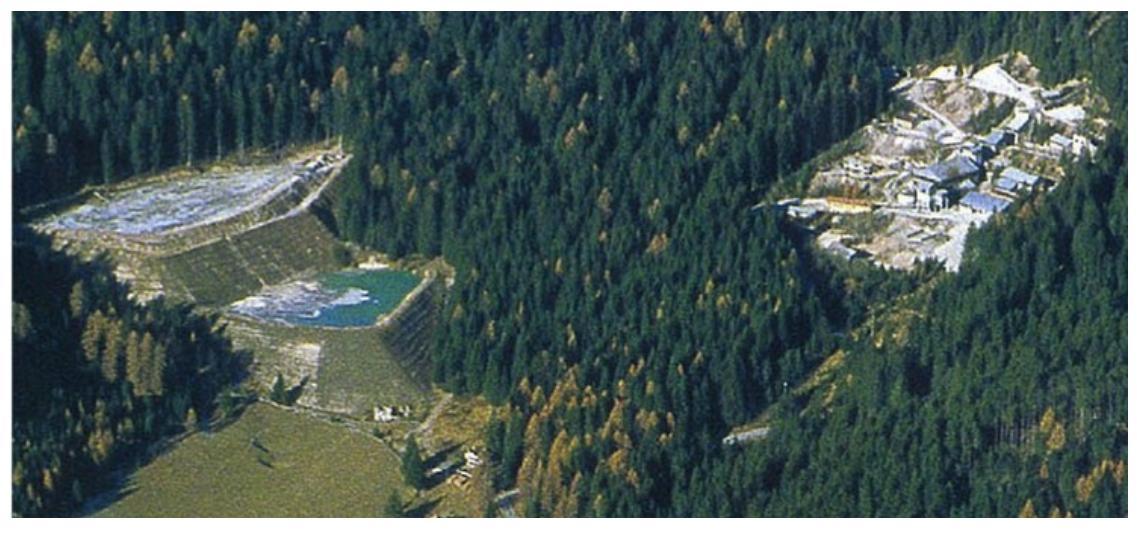
Photograph 1: Stava stacked tailings dams before failure (http://www.fiemmefassa.com)

The ponds are surrounded on the downstream side by dams 25m (lower pond) to 34m (upper pond) high, with an external slope ranging from 1.2H to 1.5H/1 V (i.e. from 33° to 40°), built according to the upstream method.

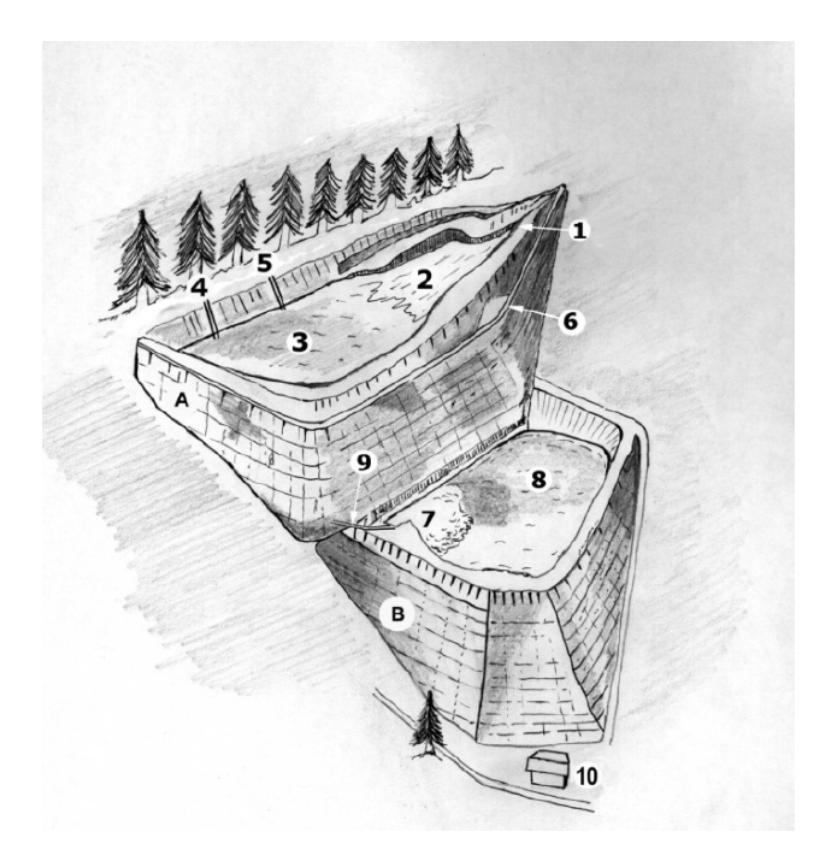
Figure 19: Detail of the two ponds (1: cyclone separation zone, 2 and 7: sand deposits, 3 and 8: silt deposits, 9: drainage of the upper pond) (Luino, De Graff [67])

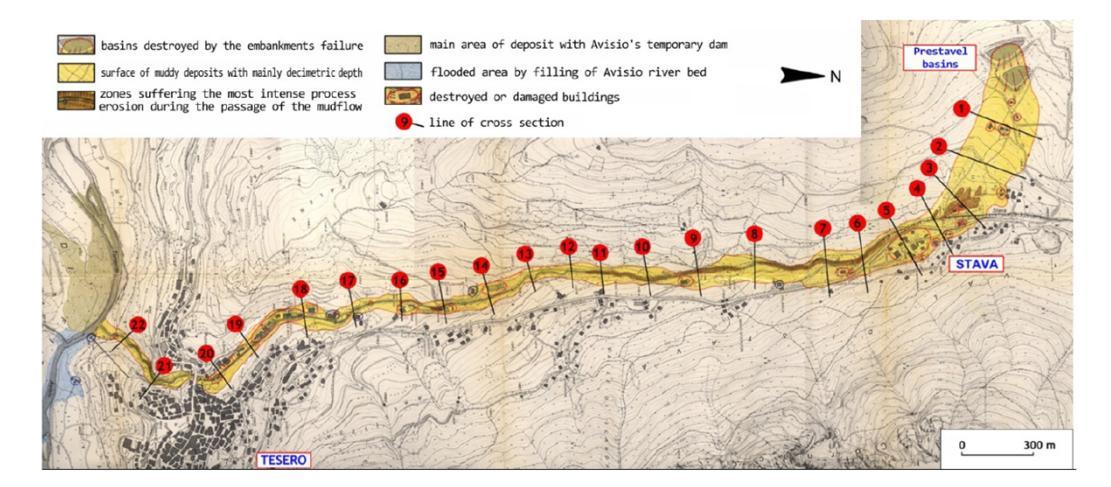
Around noon on 19 July 1985, a wave of about 185,000m<sup>3</sup> of liquefied tailings containing 95% water and with an estimated speed of 60 km/h broke through the valley to the Avisio river, engulfing the villages of Stava and Tesero in a few minutes. 269 people were killed, 62 buildings and 8 bridges were destroyed. More than 4 km downstream was devastated and the residual sludge thickness was 20 to 40cm. The damage was estimated at 155 million euros at the time.

Figure 20: Path of the sludge wave through the Avisio valley (Luino, De Graff [67])

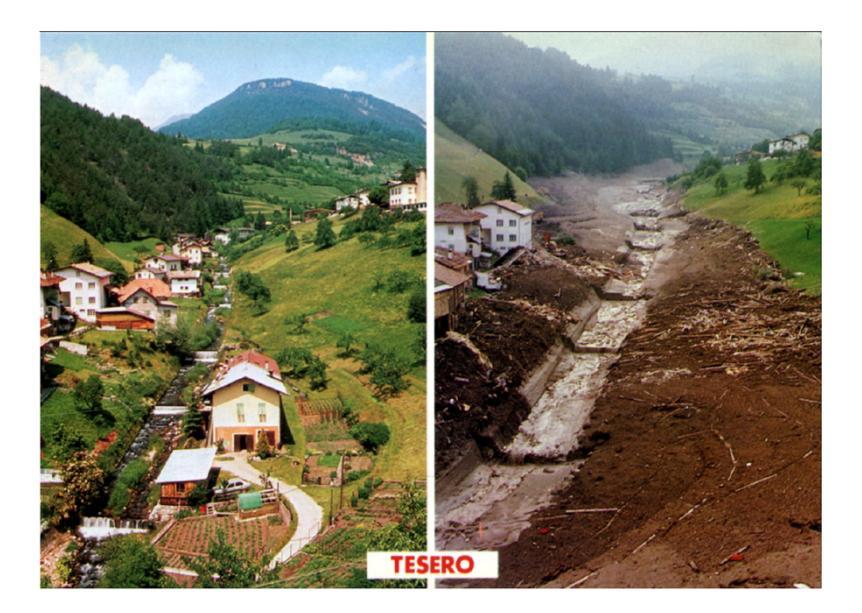
Photograph 2: Before and after shots in the village of Tesero (in Luino, De Graff [67])

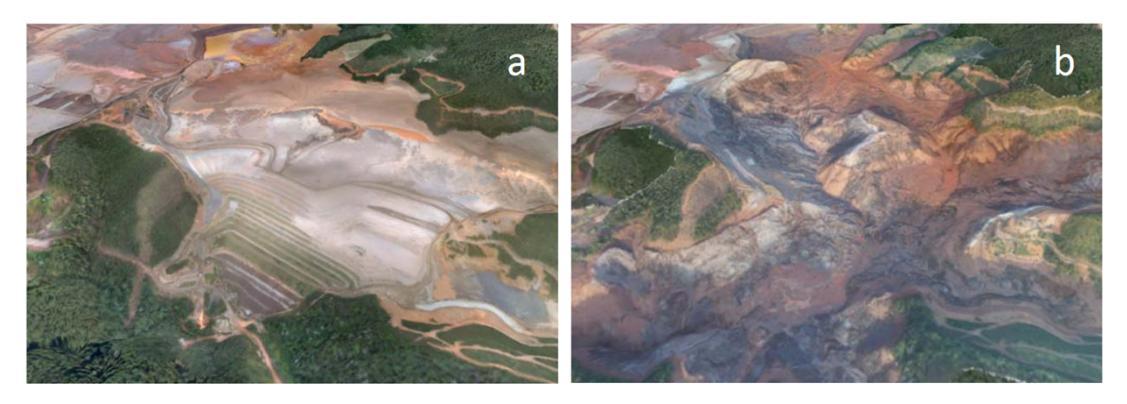
Photograph 3: Fundao dam before and after failure (Morgenstern et al. [78])

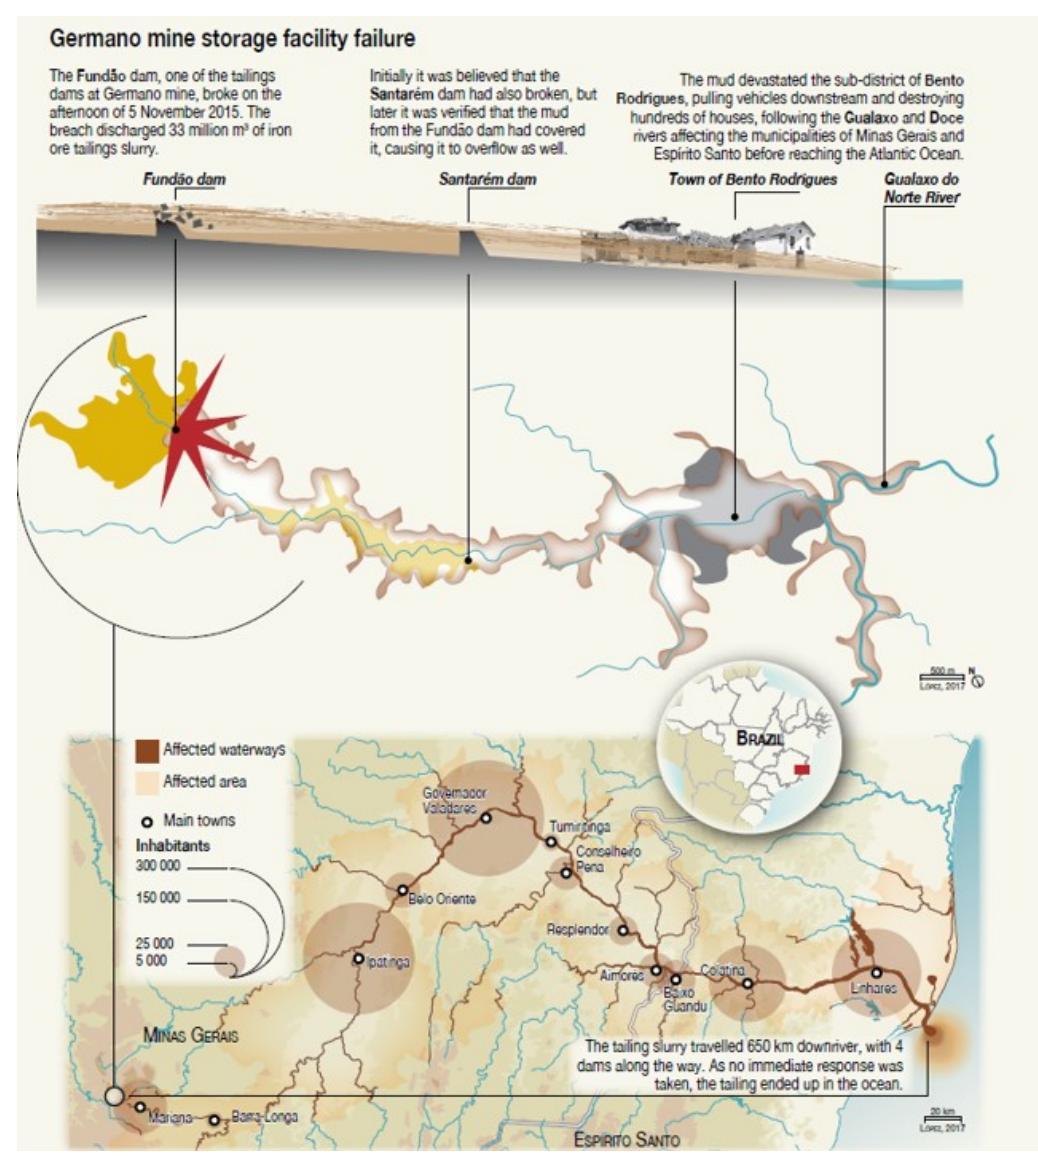
Figure 21: Impacts of the Germano de Samarco mine accident from Roche et al. [90].

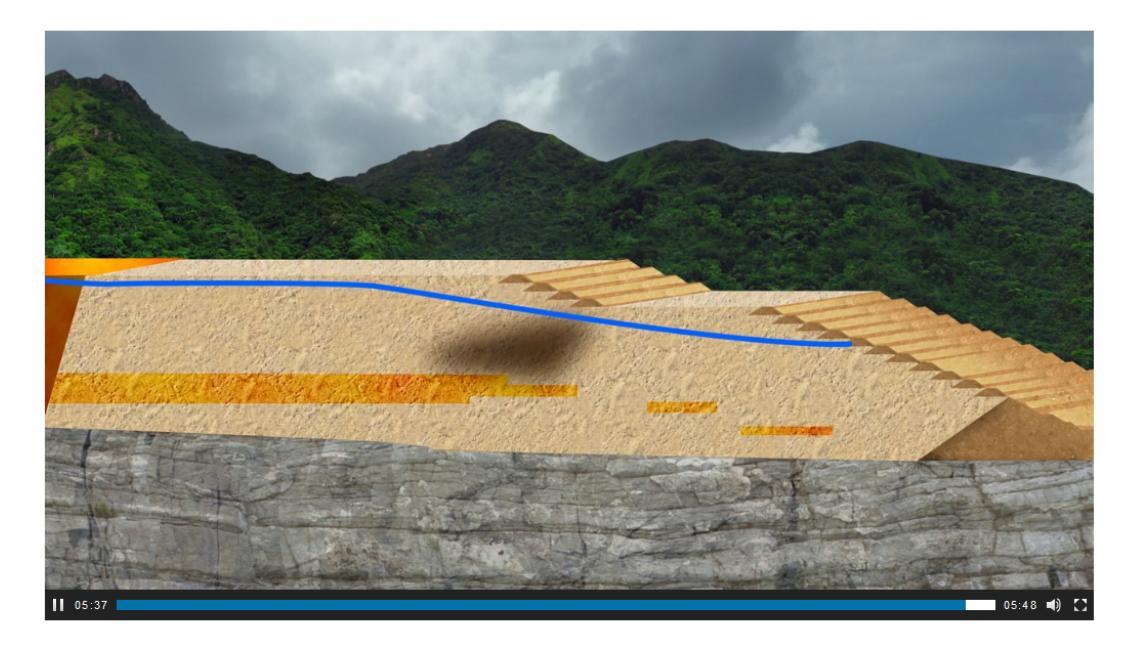
Figure 23: Extract from the animation on the causes of the Fundao dam failure. Beds of orange tailings sludge within the sand zone, leading to the rise of water (blue line) progressively up the height of it, creating conditions for liquefaction of the sand (black spot) (Fundaoinvestigation website [34])

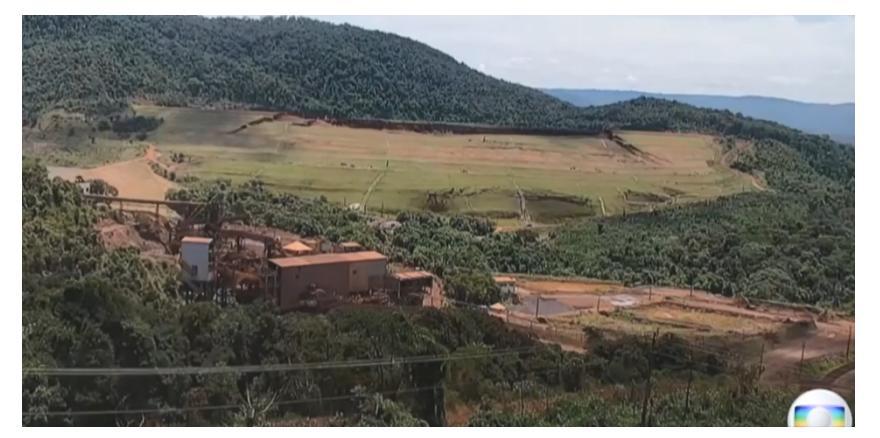
Figure 25: Image taken from the video of the failure. You can clearly see the ruptured crest of the dam and the bulging of the lower part (WMTF, [105])

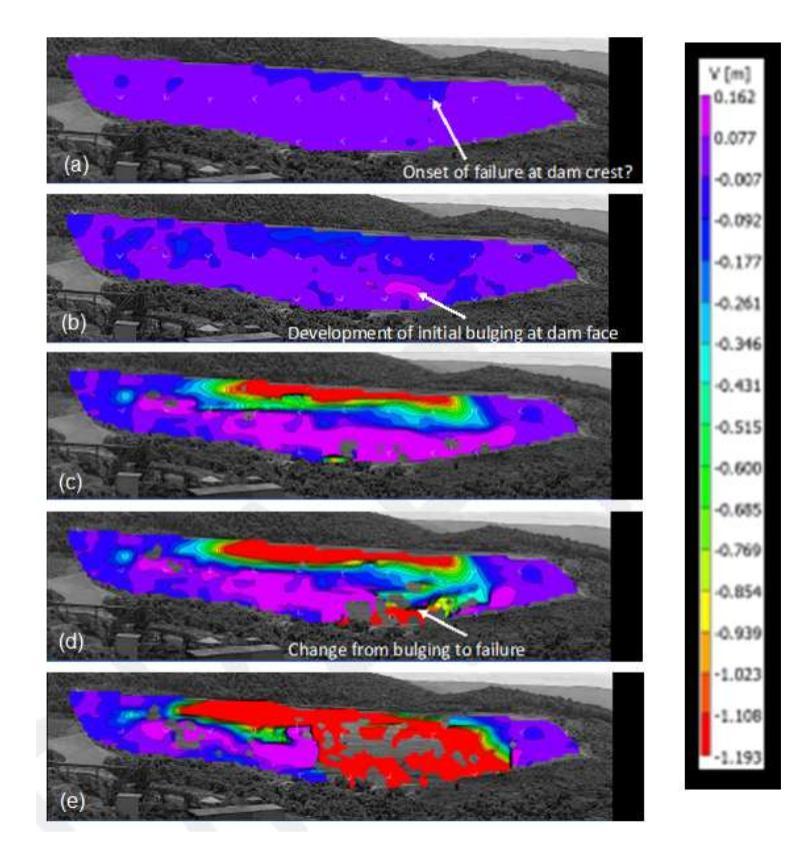
Figure 26: Fracture propagation within the dam (Robertson et al. [89])

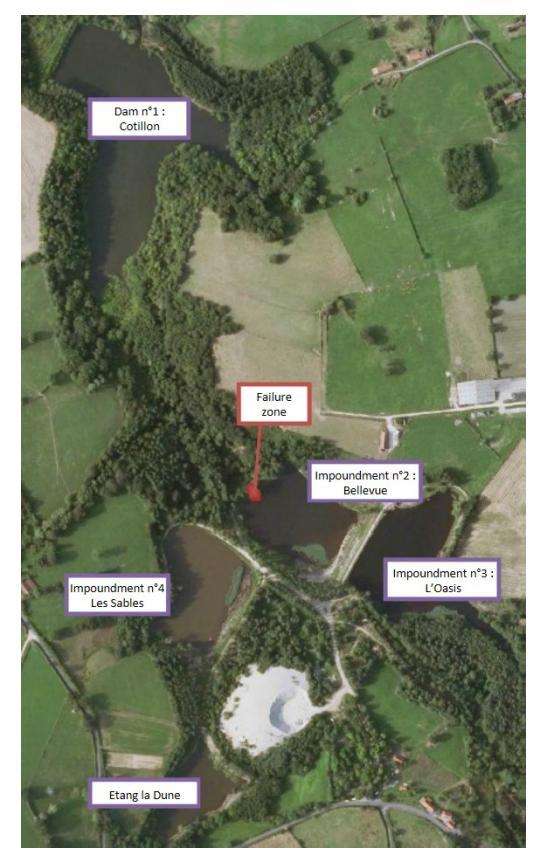
Figure 27: Former Montmins mine, Echassières. The four tailings containment structures and the breach zone (source Somival)

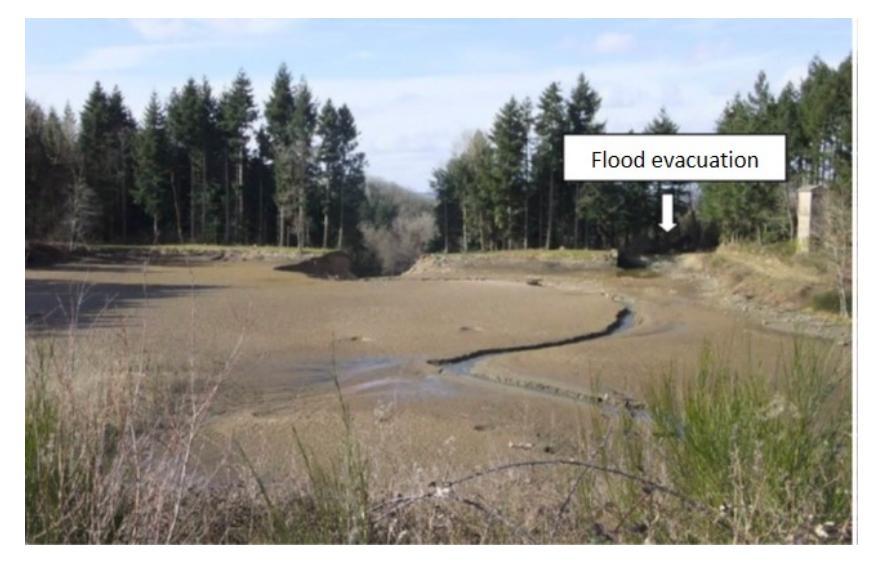
Photograph 4: Breach on 1 March 2015 in the "Bellevue" pond of the former Montmins mine, Echassières, Allier (source Somival)

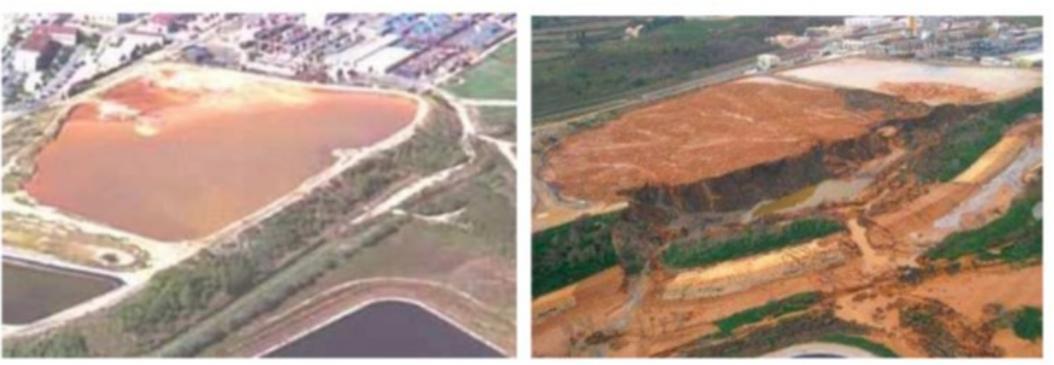
Photographs of ponds B1-B2 before and after the accident (Wise site).

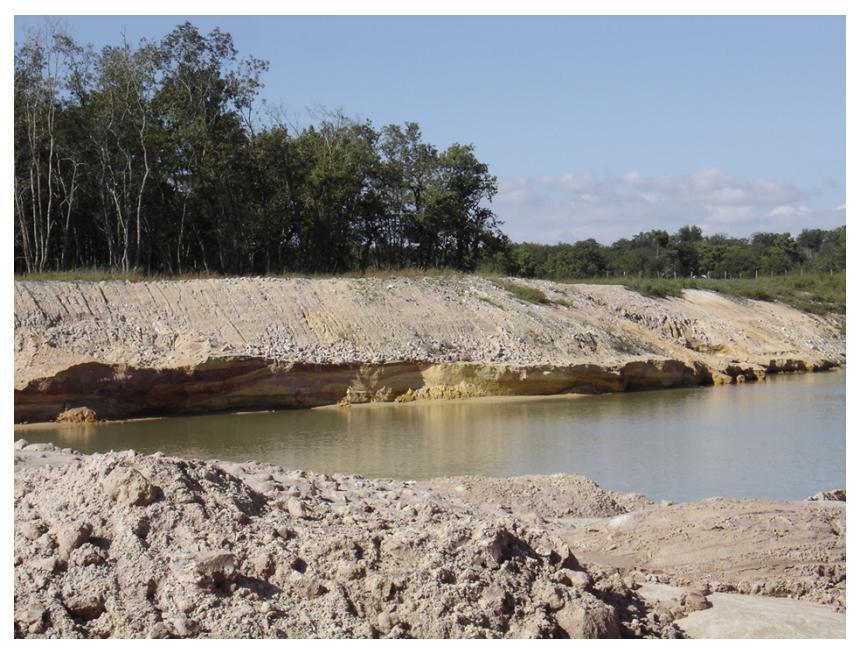
Photograph 6: Scouring of the face created by wave action in a water body (Ineris)

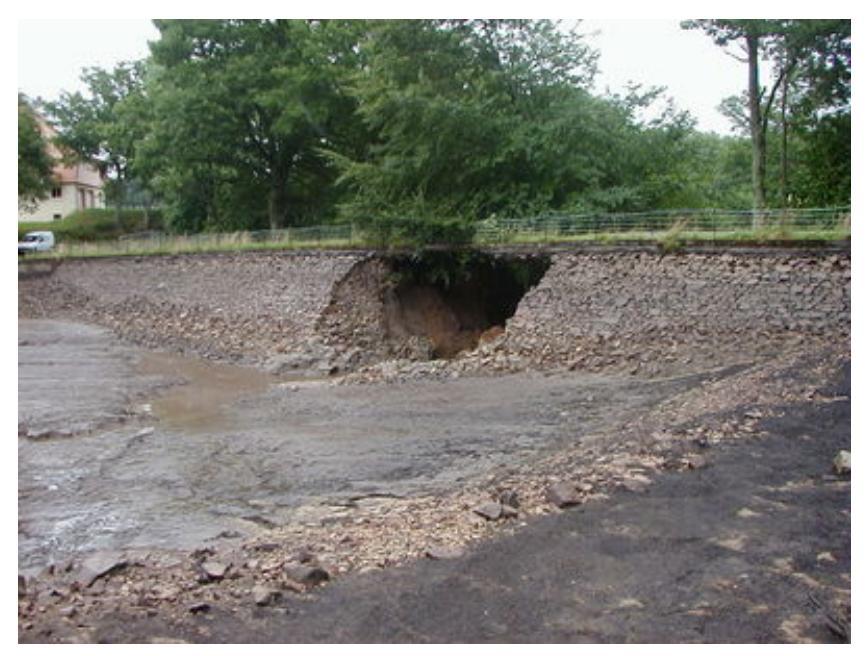
Photograph 7: Breach created by internal erosion within a levee (Irstea photo, in <u>http://wikhydro.developpement-durable.gouv.fr</u>)
