Report number : Ineris-180582-2330084-v1.0

**RISKS ASSOCIATED WITH GAS STORAGE
IN DEPLETED RESERVOIRS:**

**FEEDBACK EXPERIENCE FROM THE
ALISO CANYON (US) INCIDENT**

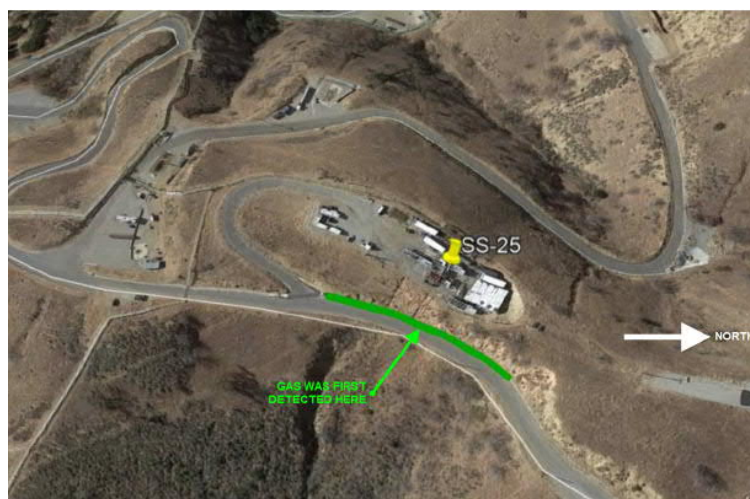
Figure 2: Location of the first gas leak zone on 23 October 2015 [14]

- 3:15 p.m.: the smell of gas is reported to SoCalGas by the staff of a subcontracting company;
- 3:20 p.m.: SoCalGas staff are deployed to the zone, find and repair a leak on a metal pipeline located on the surface near wellhead SS-25. Then they scan the zone with a portable gas detector, but no trace of natural gas is detected;
- at around 7 pm, a gas leak is observed on the main road leading to well SS-25 (see Figure 2). Staff are evacuated from the zone and the road is closed. SoCalGas mobilises to prepare for well control operations and starts recording wellhead pressures every 30 to 60 minutes.

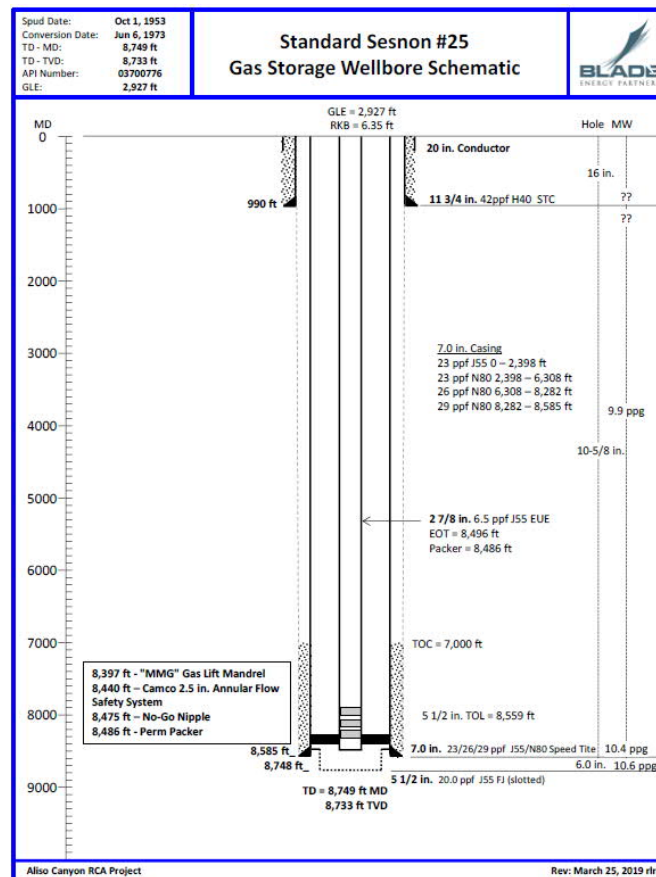
Well SS-25 was drilled in 1954, initially for the purposes of oil production. It is covered by two concentric casings, a first 11³/₄ diameter casing anchored at a depth of 300 m (990 ft) and a second 7" diameter casing anchored at about 2,600 m (8,585 ft). The 7" casing is cemented from the casing shoe to a depth of 2130 meters (7,000 ft), the remainder of the annulus being filled with drilling fluid left in place during well construction (see Figure 3). The 11³/₄ casing has no good quality cementing above a depth of 120 meters (400 ft).

Figure 3: Schematic diagram of well SS-25 in February 1979[13]

As an oil producer, the well was completed with a 2⁷/₈ production tubing, through which the oil circulated and which acted as the primary barrier, while the secondary barrier was the 7" casing.

In 1973, well SS-25 was converted into a natural gas storage well. For flow optimisation purposes, the gas was then injected and withdrawn through both the production tubing and the 2⁷/₈-7" annulus. The 7" casing then became the primary barrier, the 11³/₄ casing acting as the secondary barrier. Nevertheless, no risk analysis was carried out during this change of configuration. No reports mention an analysis of the quality of the cementing around the 7" casing, i.e. there was no log control of the cement around this casing, or any corrosion control of the casing itself [13]. Only pressure tests were performed to check the proper holding of the casing.
