# Mine shafts: improving security and new tools for the evaluation of risks (MISSTER)

# Research Fund for Coal and Steel

## **Mine shafts: improving security and new tools for the evaluation of risks (MISSTER)**

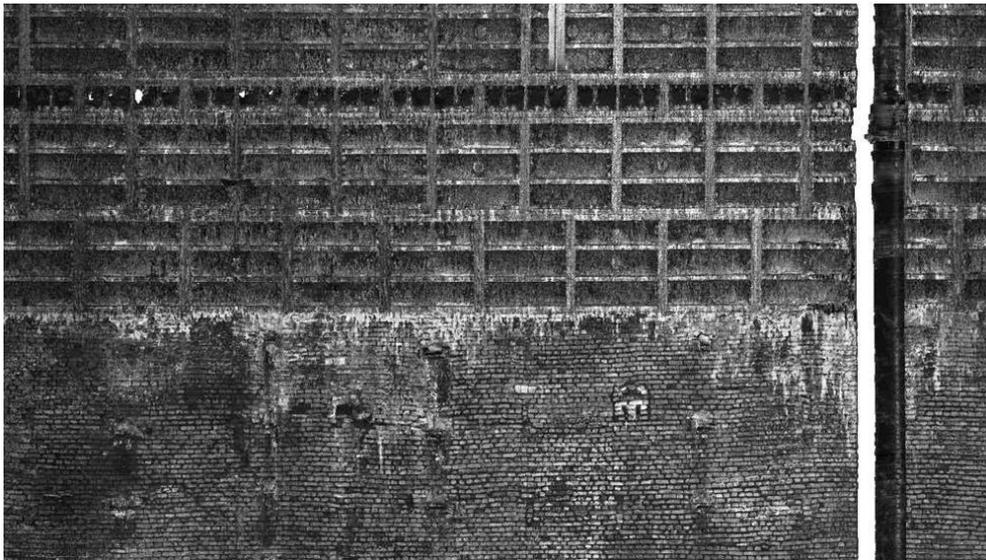
Figure 5: Unwrapped image of scan data (transmission from tubbing to brick lining)

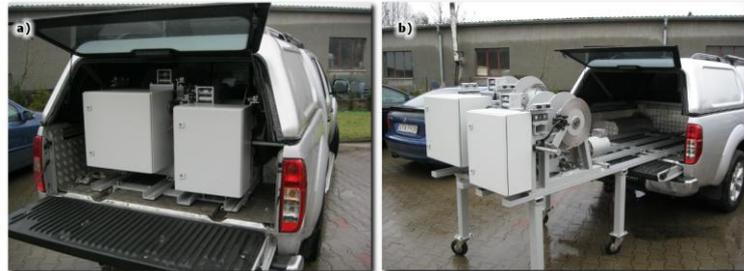
Each of the two winches for lowering main and secondary unit are equipped with a steel rope (1200 m of length) and rope spooling system. The winches speed can be control continuously from 0,0 to 1,5 m/s. During the shaft inspections the winches are secure mounted in the cargo area of a car - Nissan Navara.

**Winches for lowering the main and secondary units  
a) mounted in the car, b) unmounted for maintenance and service**

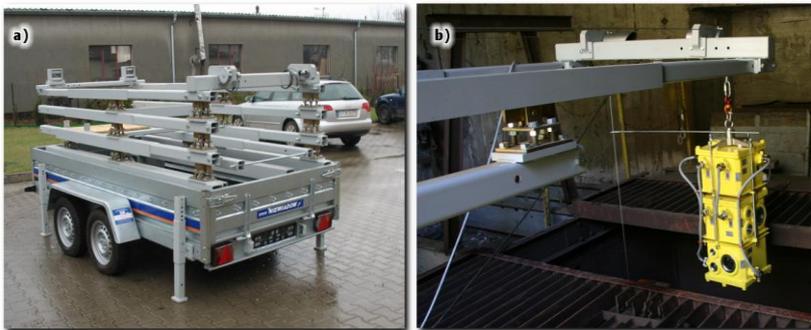
**Car trailer with jibs  
a) folded and prepared for transport, b) fully extended and placed over the shaft**

Car trailer is equipped with depth-encoders, WIFI antenna and special jibs enabling precise guidance of the probe anywhere in the area of the shaft.

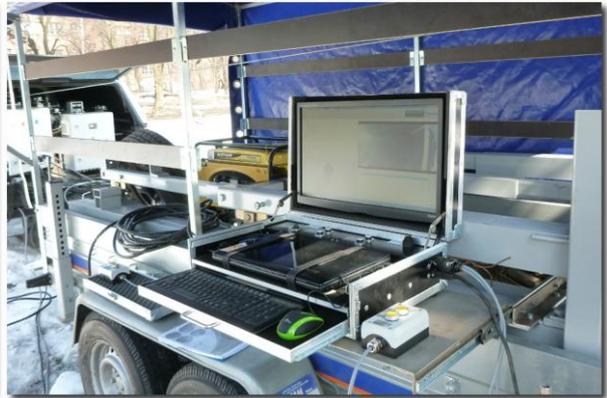
**Monitoring&Control Unit**

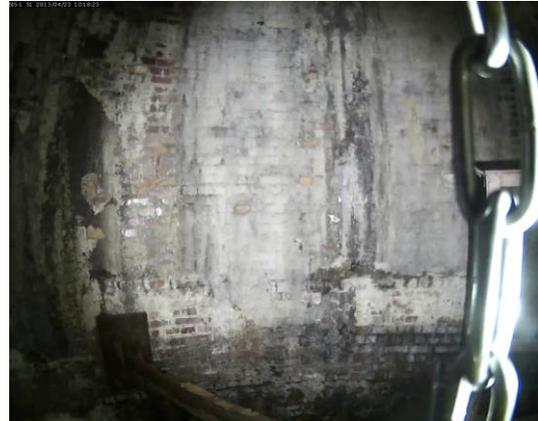
**Example image recorded during shaft inspection**

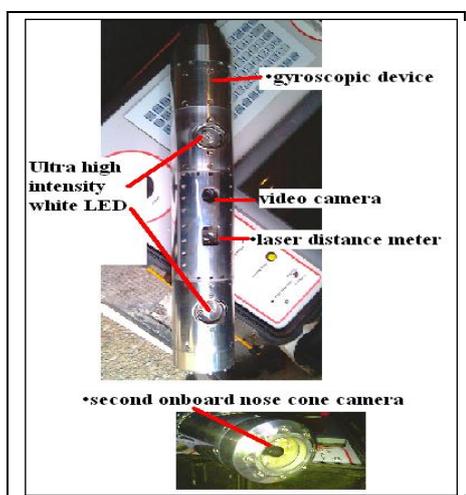
**Camera for flooded voids (probe 4)**

The probe is built to work in flooded conditions (max <1400 kPa) like in some old mine shafts. It requires a drilling of 100 mm diameter.

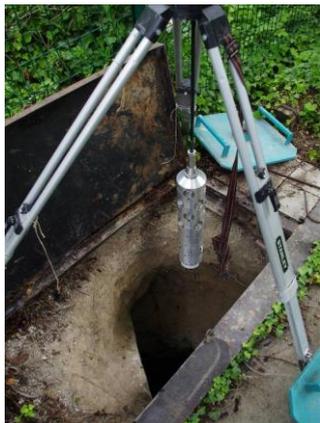
Inspection of cavities and shaft with the winder located directly at the top of the shaft or at the top of a borehole

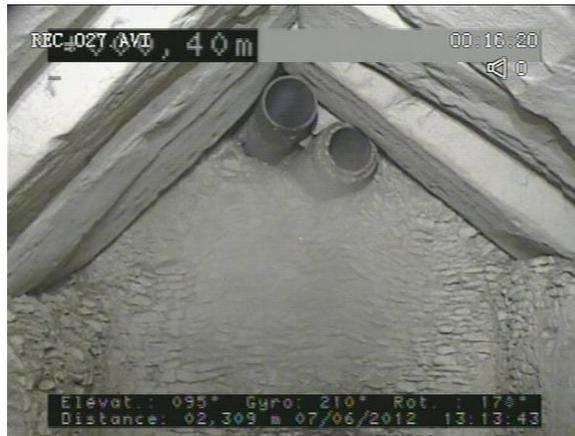
Digital picture taken by the acquisition card (example of closure of the head of an old shaft)

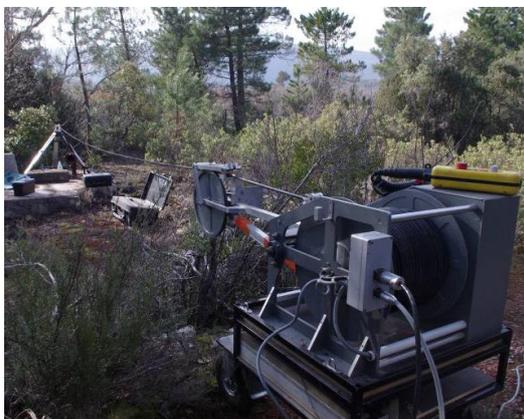
Inspection of cavities and shafts using a tripod or a deviation pulley
