STUDY REPORT  
DRS-15-149641-02735A

**LESSONS LEARNED FROM ACCIDENTS RELATED  
TO THE EXPLORATION AND PRODUCTION OF  
HYDROCARBONS**

## **Ground and Underground Risks Division**

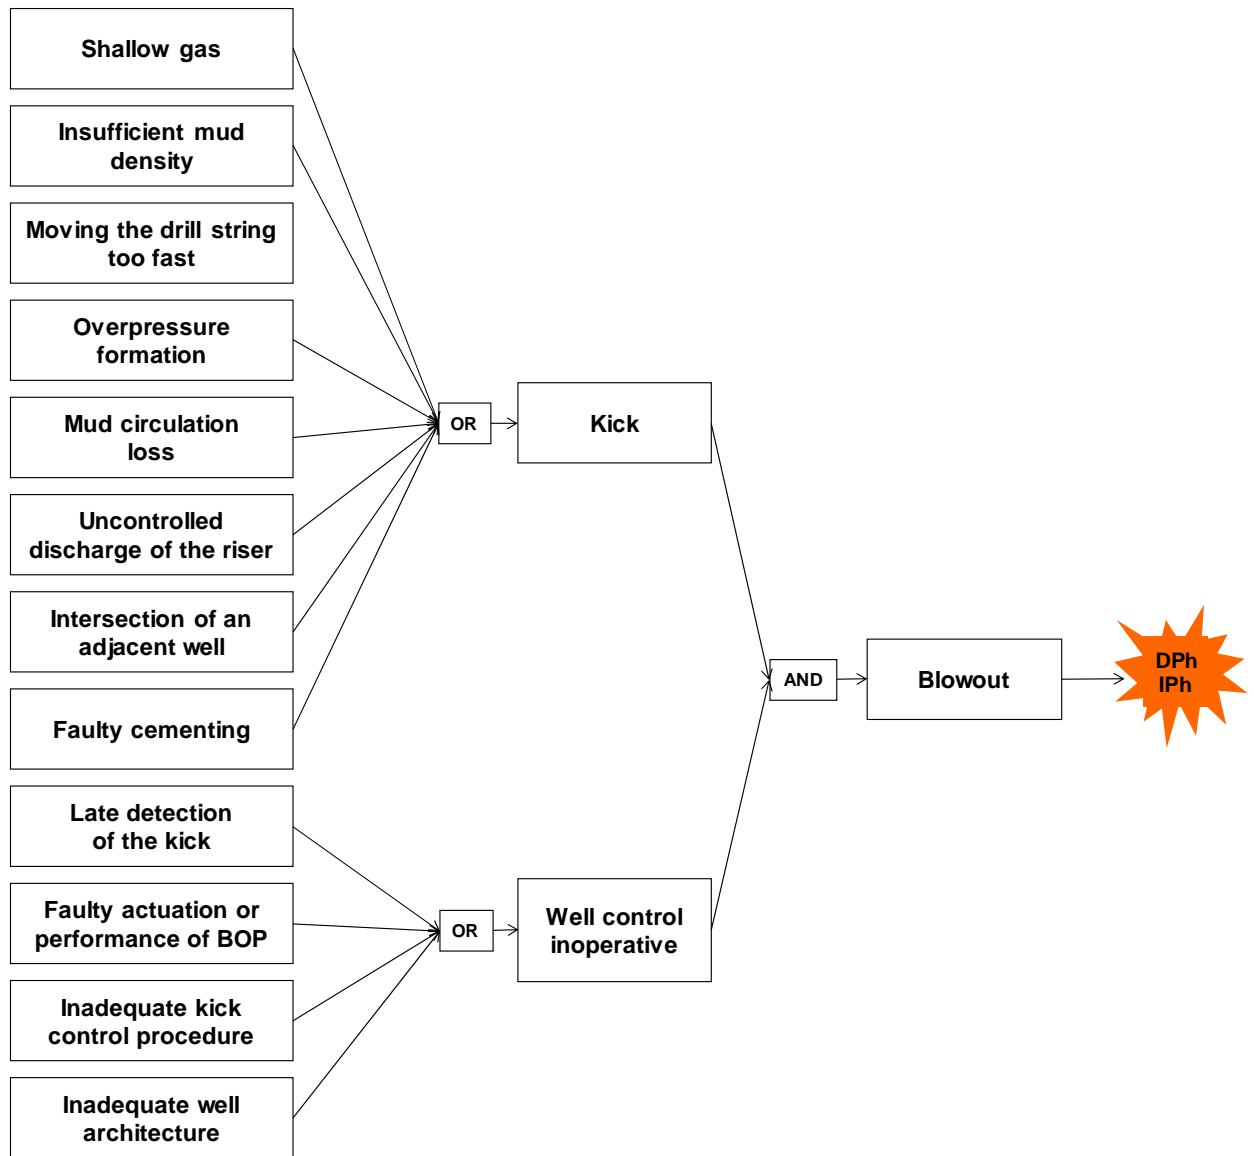
Figure 25: Summary of the main blowout scenarios during drilling highlighted by accident research. The phenomenon generated can be a dangerous phenomenon (Dph), i.e. potentially having an impact on humans, or an impacting phenomenon (Iph), i.e. a phenomenon which could impact the environment .

Figure 25 summarizes the blowout scenarios reviewed above.

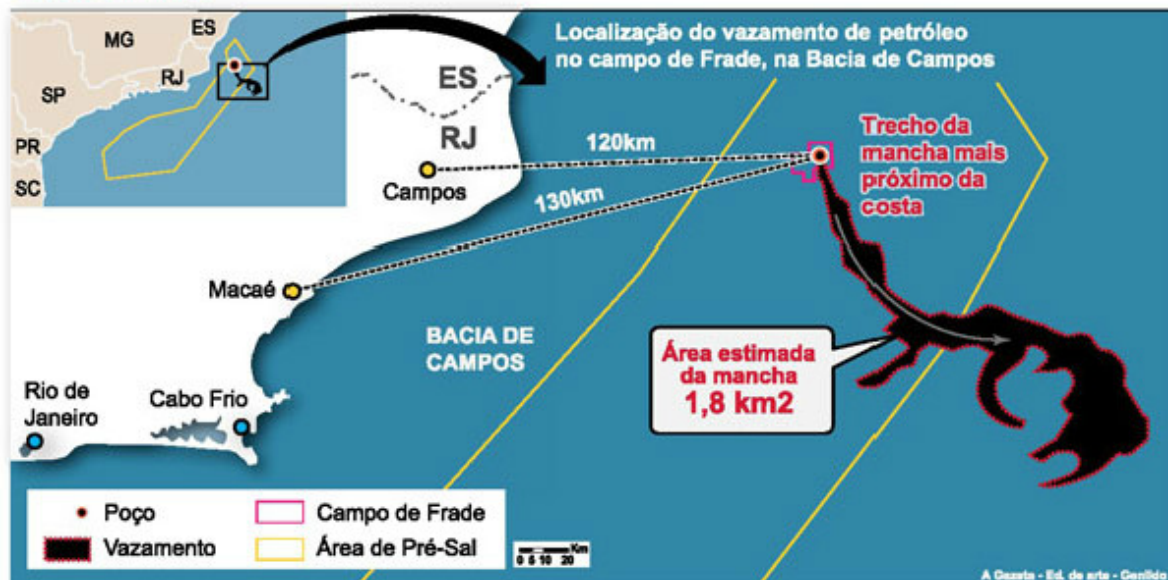
*Location of the oil slick [5]*

- 590 m<sup>3</sup>, i.e. approximately 470 tons of petroleum spilled into the sea [1];
- Oil slick of 1.8 km<sup>2</sup> [5].

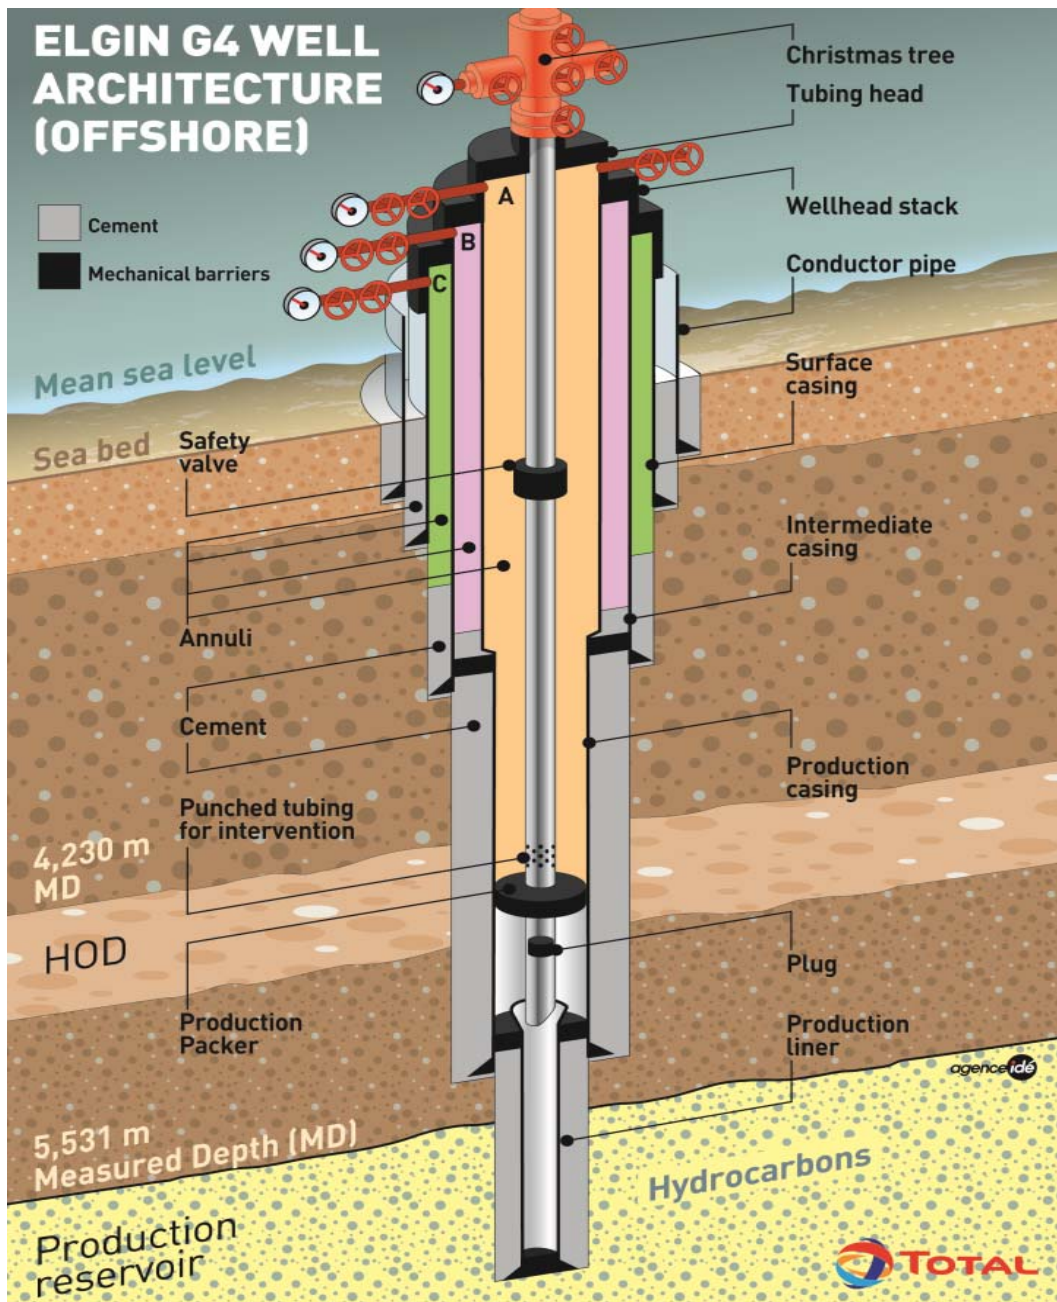
**Architecture of well G4 [3]**

- Well G4 was a production well up until January 2011. Production irregularities were noted during the month of January. The decision was made to stop production, then temporarily close the well;
- The annulus pressure was monitored after this incident;
- A high annulus pressure was observed again in December 2011. It was decided to definitively abandon the well;

During this operation, a gas and condensate blowout occurred under the well head at platform level.
